PHILADELPHIA CHARTER SCHOOL

Retrofit Report

07/13/2020

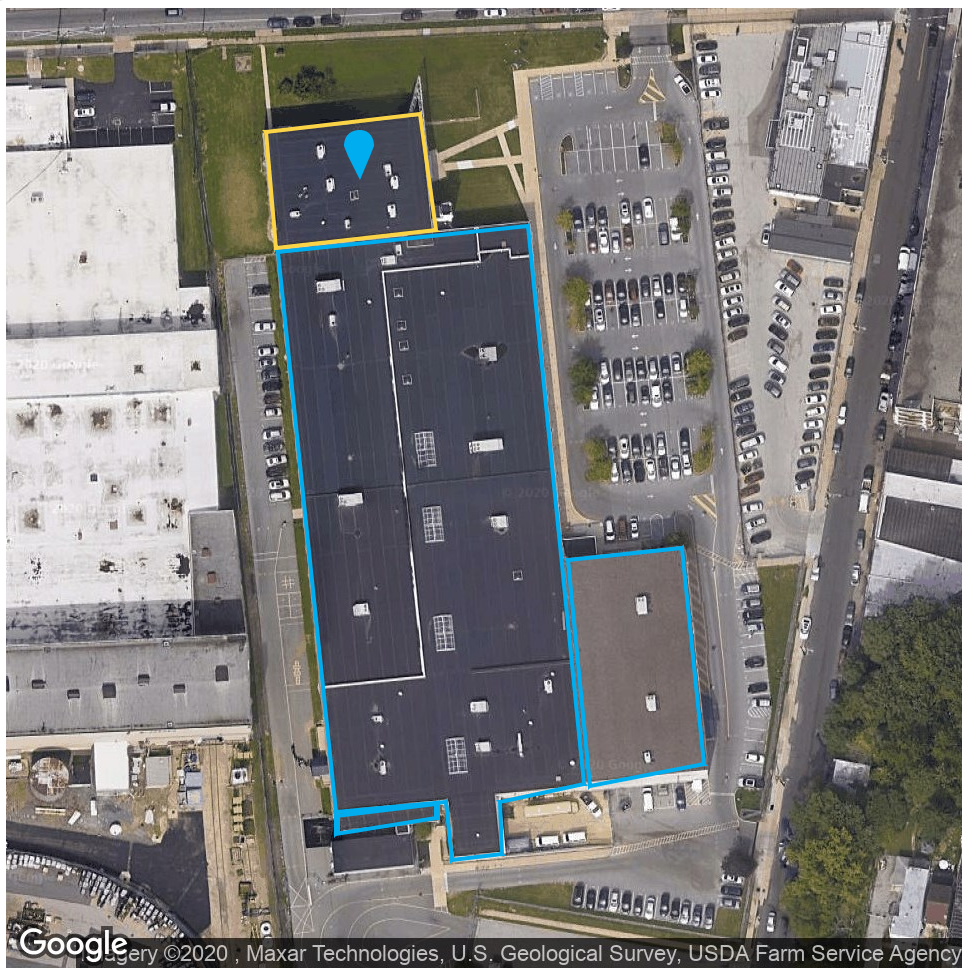
Section A Overview: High Roof

Section Outcome:
Replace

Severity:
Major

Leave the existing roof in place since the core samples show that the existing insulation is dry. Existing composition is 2.5" polyiso mechanically attached to the metal deck. The existing membrane is reinforced EPDM which is also mechanically attached. Suggestion is to add a layer of 1" mechanically attached polyiso through the existing materials into the metal deck. A new TPO membrane will be mechanically fastened over the 1" polyiso. Upon completion of the project a new 20 year warranty will be issued.

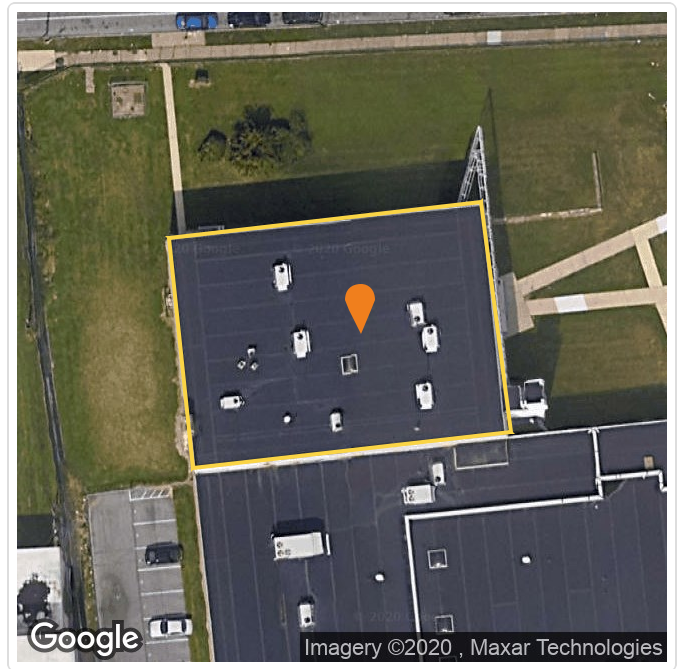
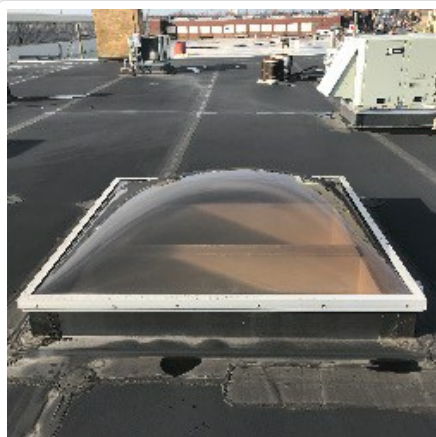
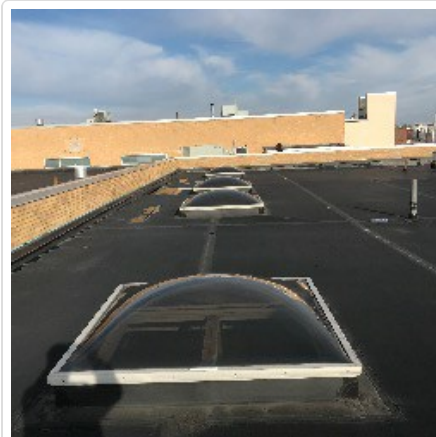
Issue AI-1: Skylight Dome

Domes are aged and will eventually become an issue. It would make sense to accept a line item price to replace the current domes now before they become an issue. There are 6x6 skylights on both the main roof and also on what we are calling the high roof.

Water can enter the building through the compromised skylight dome and this will not be a condition covered by the roofing warranty.

Severity:
Moderate

Action:
Monitor

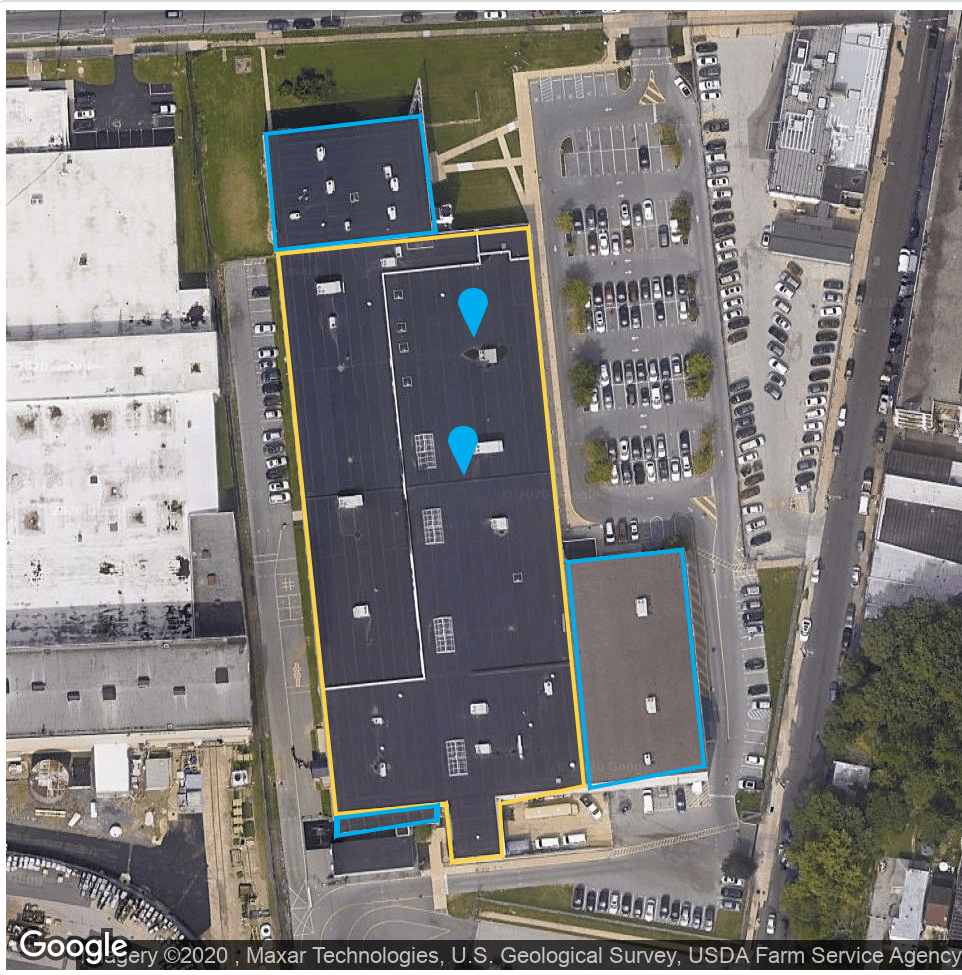
Section B Overview: Main Roof

Section Outcome:
Replace

Severity:
Major

Replace this roof section by the same means & methods described in the high roof section. These roof areas were installed at the same time and contain the same existing composition as the high roof.

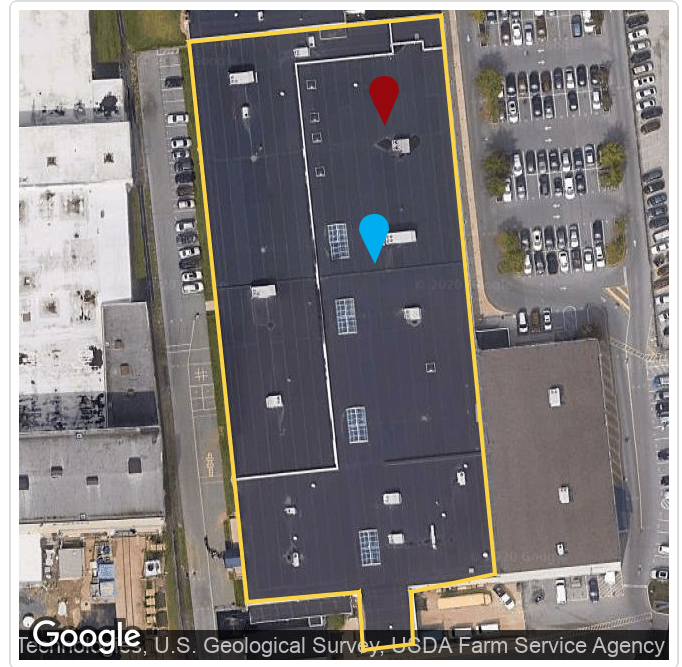
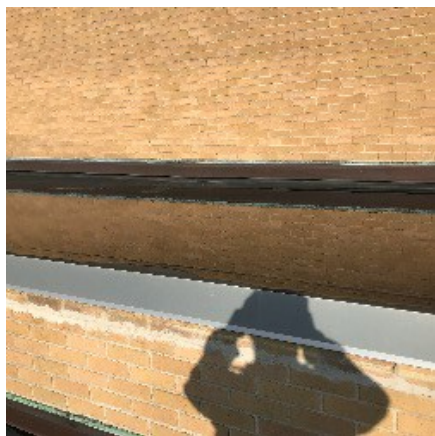
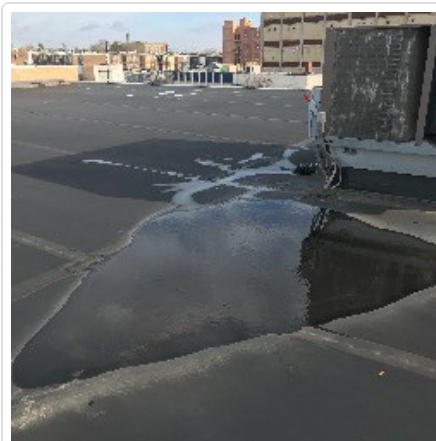
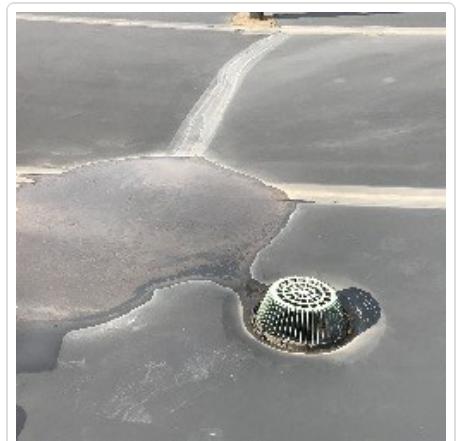
Issue BI-1: Ponding

Ponding is caused by the building's roof top drainage system not having been designed properly or ponds form as a result of such common conditions as building settlement and deck deflection.

Ponding is moderate on most of this roof section. There is a small raised roof (top photo on left) is completely holding water. The other two photos show very moderate issues. Photo with ponding behind the RTU could be addressed by adding a cricket. Third photo shows a common theme that some water is not making it to the drains. We could add or enlarge sump areas at drains to collect more water. None of these areas qualify as critical, but we should discuss options to remedy the problem.

Major

Requires Repair

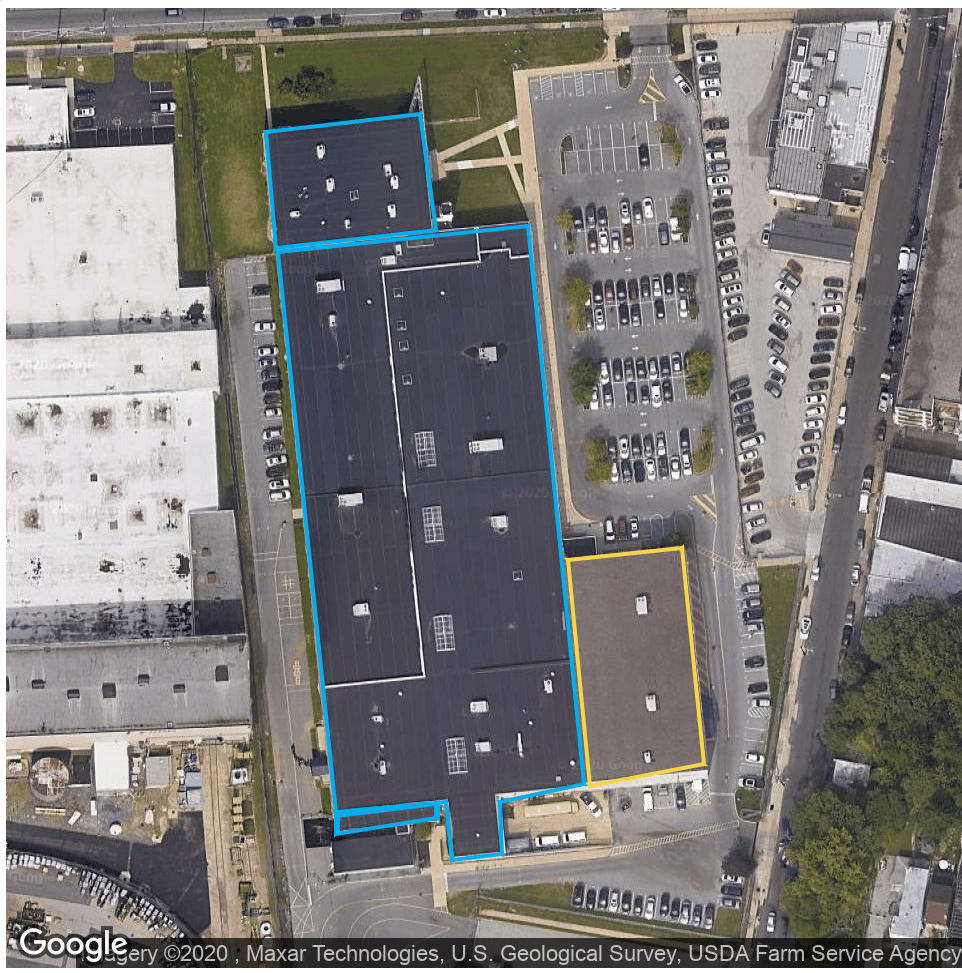
Section C Overview: Gym Roof - NIC

This section is fine. It was replaced several years ago and does not need to be addressed at this time.

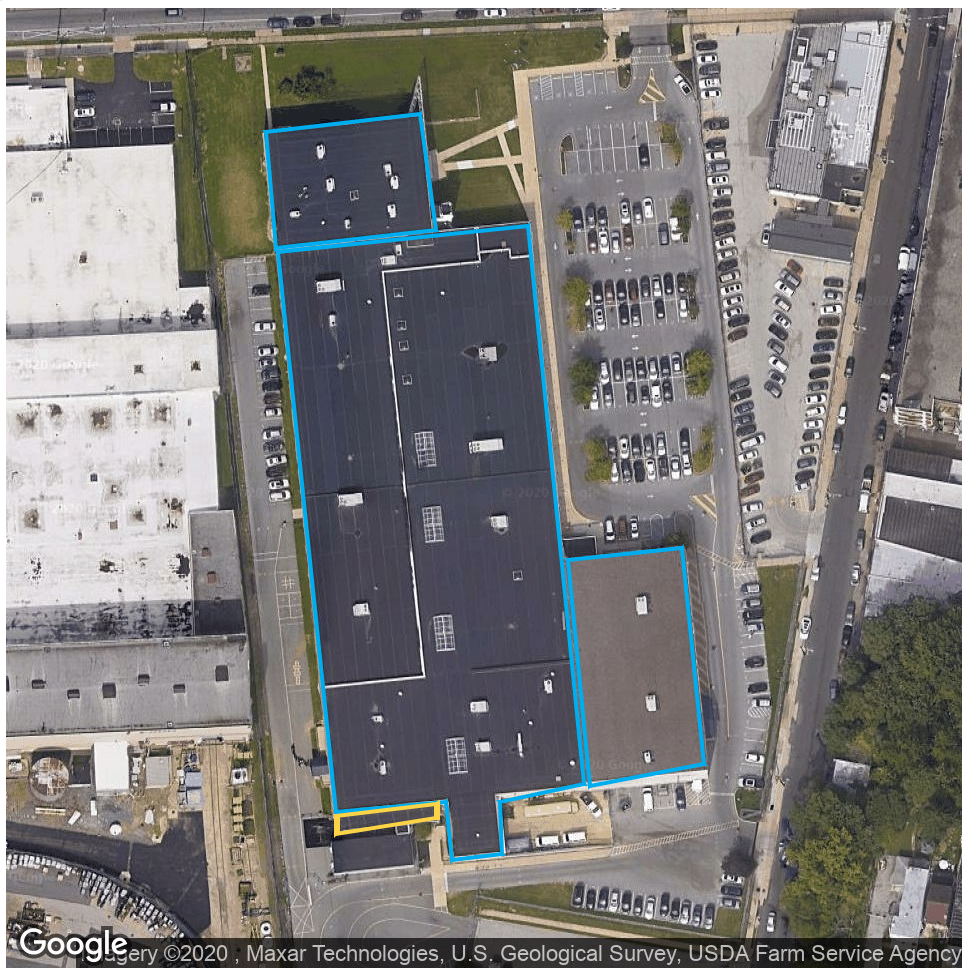
Section D Overview: Canopy Roof

Section Outcome:
Replace

Severity:
Major

Replace this section in the same fashion described in the high & main roof areas.
